## CASE STUDY – 36

### CropScan 4000VT On Combine Grain Analyser

#### CROPSCAN 4000VT VALIDATION REPORT ON NEXT GEN COMBINES

Machine Platform: CNH Next Gen Combines CR 11 / AF 10 / Case IH 8260

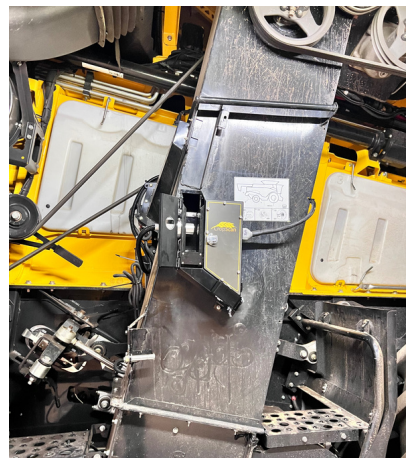
**Figure 1 Sample Head Installation**

The CropScan 4000VT was successfully installed across six CNH Next Generation Combines, including the CR11, AF10, and 8260 platforms. The installation process was significantly streamlined compared to previous models, with average times of 90 minutes for both the Sample Head and Spectrometer, and 30 minutes for cabling. The introduction of new alloy templates improved hole alignment and installation precision for both sensor components. During the validation phase, minor wiring conflicts were identified—particularly on the early CR11 prototype—which were resolved by reviewing and modifying the wiring pinouts. These findings led to small design adjustments and highlighted the value of testing pre-release machines. Overall, the installation experience was straightforward, repeatable, and represents a notable improvement over legacy systems such as the 8250 series.

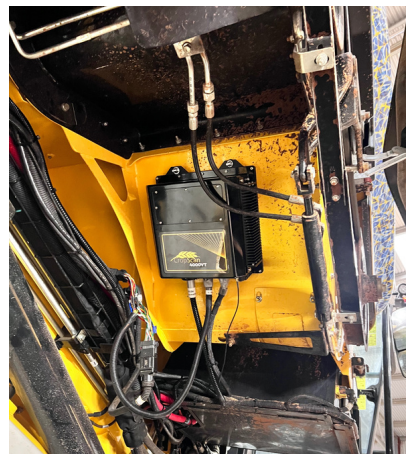
**Figure 2 NIR Spectrometer Installation**

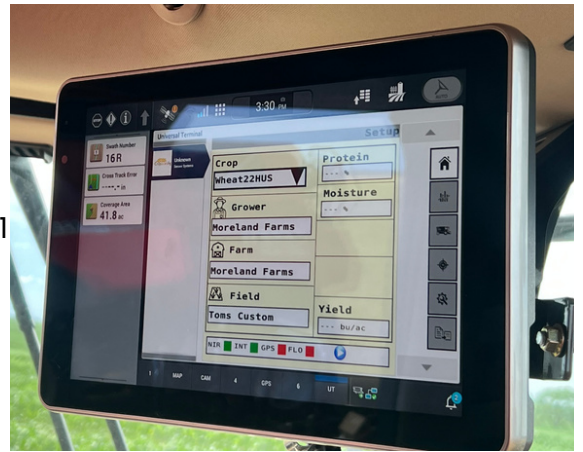
**Figure 3 Virtual Terminal**
